National Highway Traffic Safety Administration

Case Vehicle (A): 2000 Land Rover Type: Discovery II, 4-door SUV

Driver: 32-year-old male CDC: 12-FYEW-3

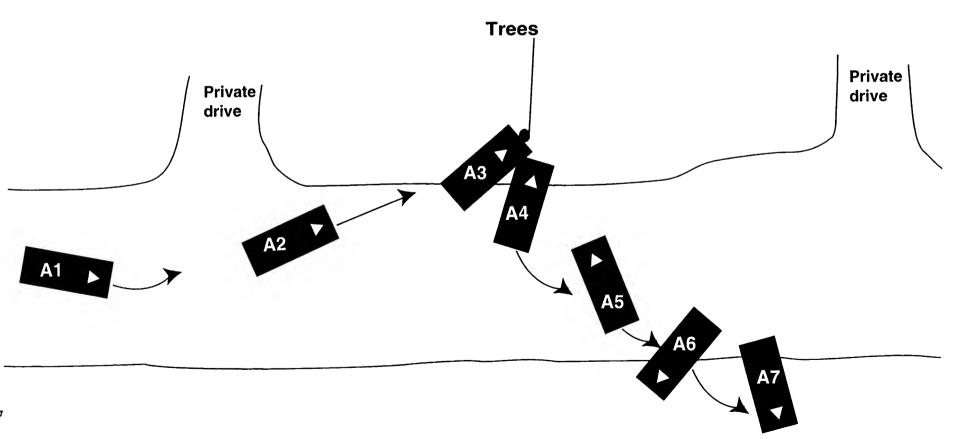
| ACCIDENT DESCRIPTION: (ase vehicle (A) was traveling in the eastbound CASE VEHICLE (A): 2000 Land Pover 7 | Discovery |
| lane of a straigh section of a snowy, dirt roadway. The driver OTHER VEHICLE (B): N/A | 7 |
| of Case vehicle (A) had two day exporience driving the vehicle THIRD VEHICLE (C): N/A | |
| Case vehicle (A) began to fishtail to the left. The driver tried to correct the yaw but lost | |
| control of case vehicle (A) as it began to fish tail to the right. Case vehicle (A) chove off the left | |
| Side of the road and Struck a tree, enforced a clockwise votation, crossed the road, and come to nest | |
| on the right shoulder facing south. | NORTH |

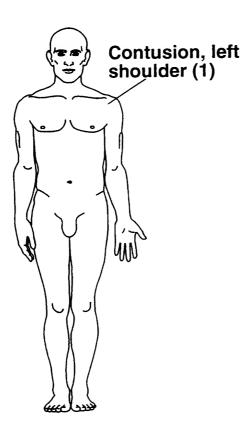
INDICATE LOCATION OF INJURIES.

| Maximum A.I.S. Level Injury Severity Score A.I.S. Definite Probable Possible Shoulder belt webbing A.I.S. Definite Probable Possible Possible | | | Injury Source | | | |
|---|---|---|---|---|---|--|
| | Contusion, left shoulder | 1 | Shoulder belt webbing | | | |

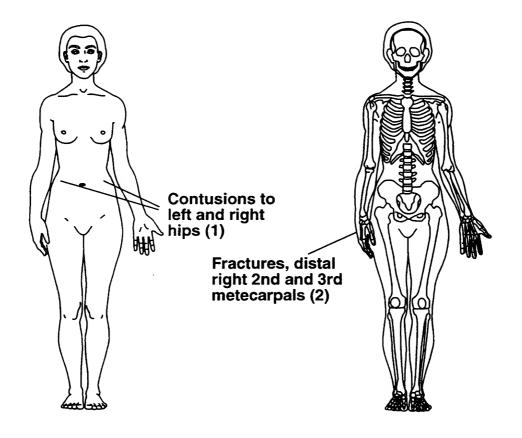
INDICATE LOCATION OF INJURIES.

| | | Injury Source | | |
|---|---|---|---|---|
| Fractures, impacted distal right 2 nd and 3 nd metacarpals | 2 | | | Interior side surface – airbag fling |
| Contusion, left hip | 1 | Lap belt webbing | | |
| Contusion, right hip | 1 | Lap belt webbing | | |
